Application News

No. A414

Analysis of Contaminants in Foods

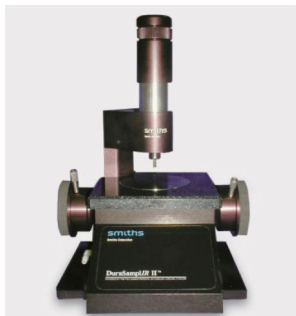
Fig.1 DuraSAMPLIR II

Since foreign matter in food is often large enough to be seen with the naked eye, here we conducted analysis using a single reflection ATR accessory (DuraSAMPLIR II), capable of measurement up to about 100 μm .

Fig. 1 shows a photograph of the DuraSAMPLIR II used for the analysis. The analytical conditions are shown in Table 1.

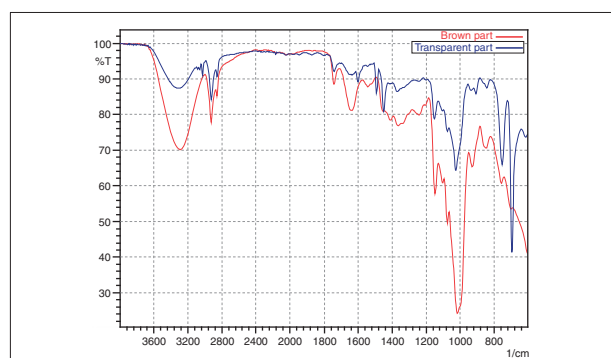
Fig.3 Spectra of Contaminant in Riceball

The size of the contaminant is about 30 mm, and there appear to be parts that are transparent and parts that are brown in color. We conducted analysis at 2 sites that were different in color. The spectra obtained from these sites are shown in overlaid fashion in Fig. 3.

Since this contaminant was found in a riceball, there is a possibility of it being an ingredient of the riceball that was adhering to its surface. The measurement result in Fig. 3 from the especially brown-colored site shows a large peak in the vicinity of 1200 - 900 cm^{-1} , suggesting that this is due to starch. Therefore, this peak is thought to be due to the influence of a piece of a rice grain adhering to the surface of the contaminant. A peak also believed to be due to starch was found in the measurement result of the transparent site, but due to its small intensity, it is believed that just a small amount is adhering at this site. Then, to eliminate this influence and obtain only the spectrum of the contaminant, the difference spectrum of both the spectra (transparent part - brown part) was obtained. Fig.4 shows the obtained difference spectrum.

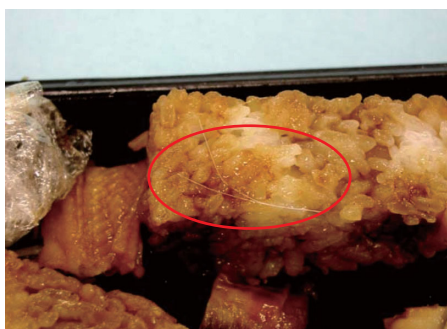
Fig.6 Photograph of Contaminant in Sushi

Fig. 6 shows a photograph of a fiber-shaped contaminant adhering to the surface of a piece of sushi. Fig. 7 shows the results of analysis of this contaminant.
